# Pre-Renovation Asbestos Survey

Cabot Apartments  
13725 Dexter Avenue  
Detroit, Michigan 48238

**April 15, 2025**

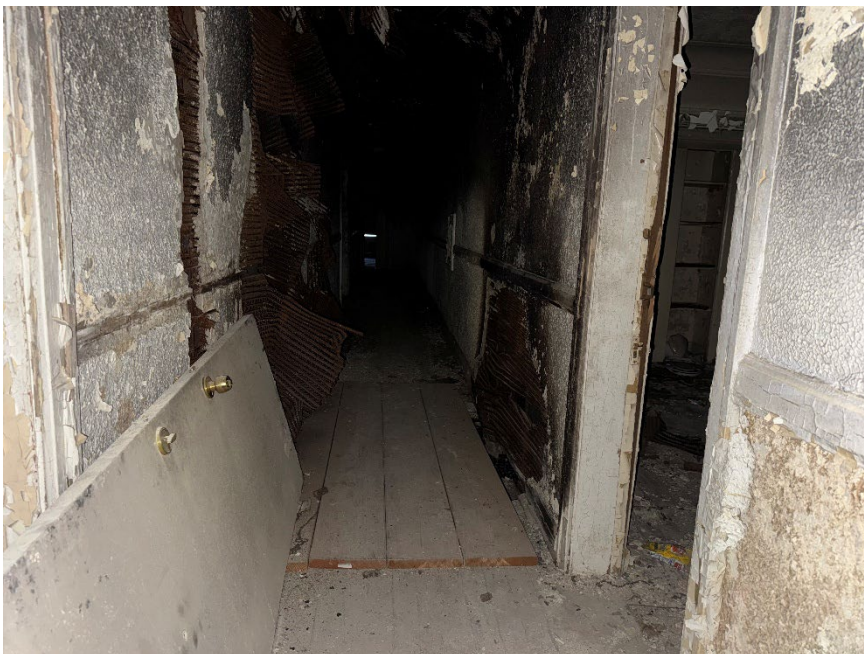
**Photograph #18**

View of first floor hallway  
(wooden planks to cover  
hole in ground)

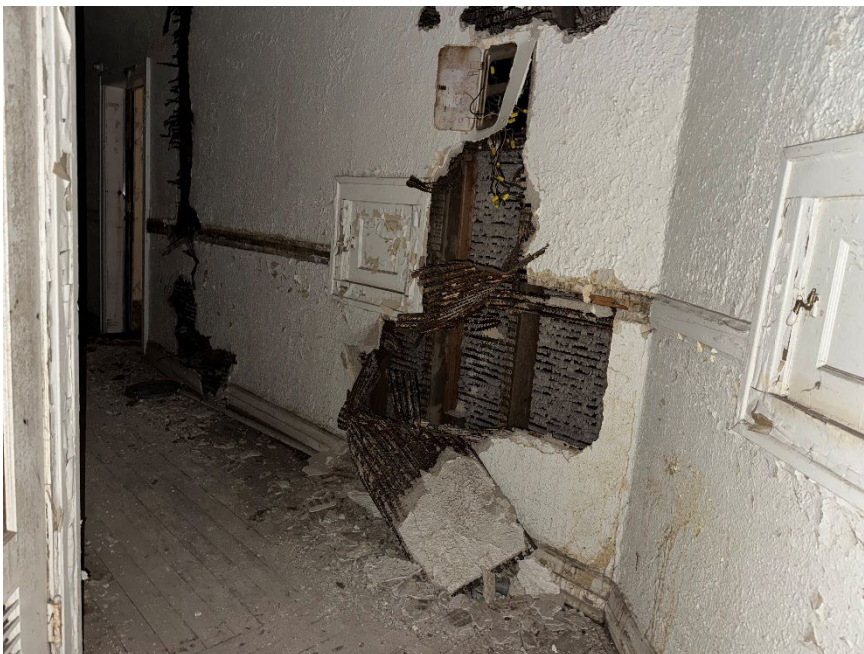
**Photograph #20**

View of structural damage done to walls (seen widely throughout subject property)

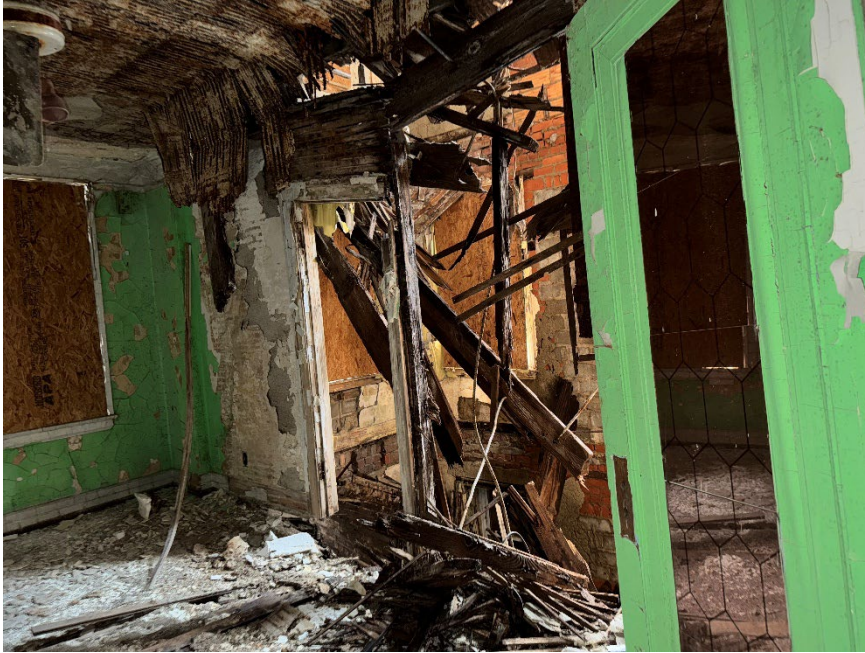
### Photograph #21

View of structural collapse in north side of subject property

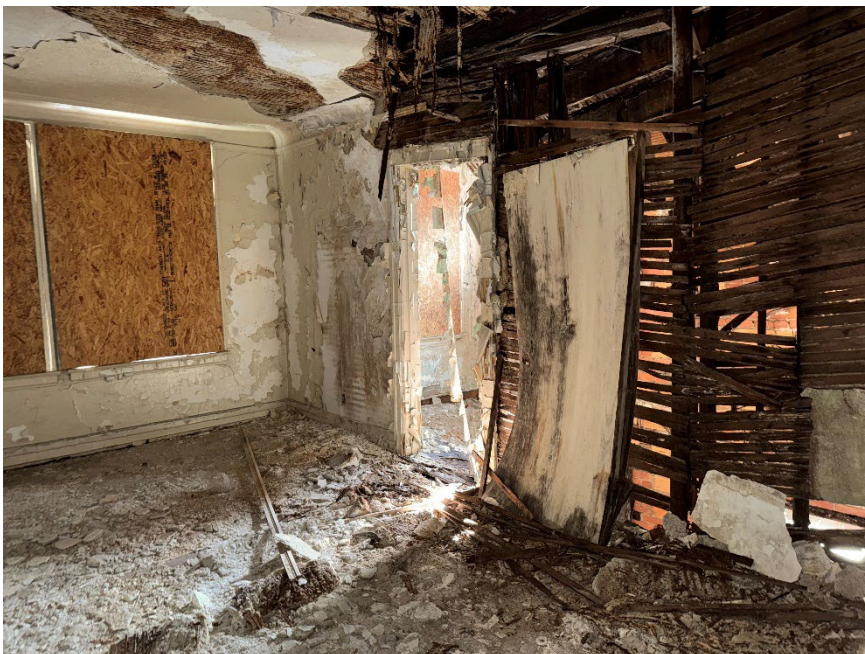
### Photograph #22

View of structural collapse in north side of subject property

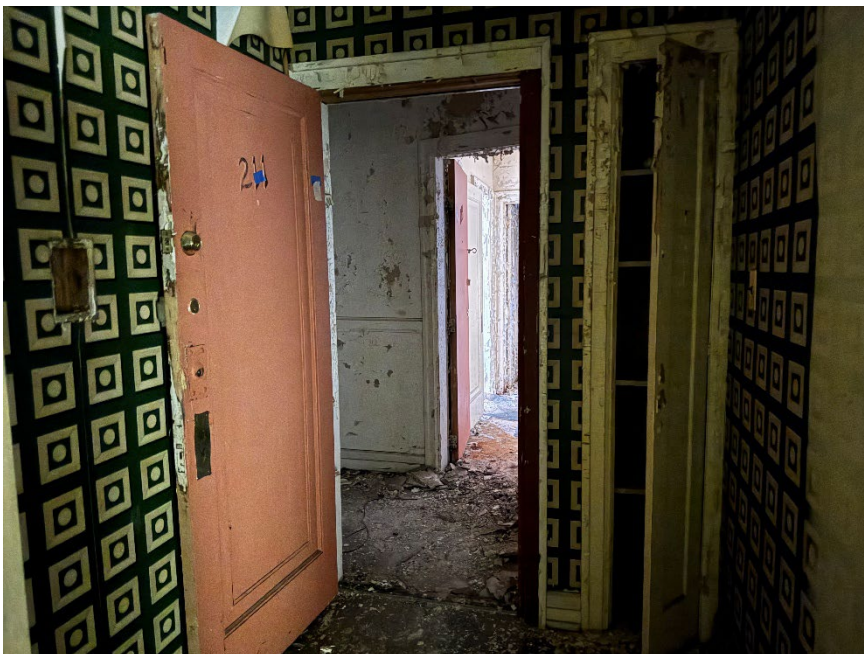
Photograph #26

View of wallpaper found on second floor

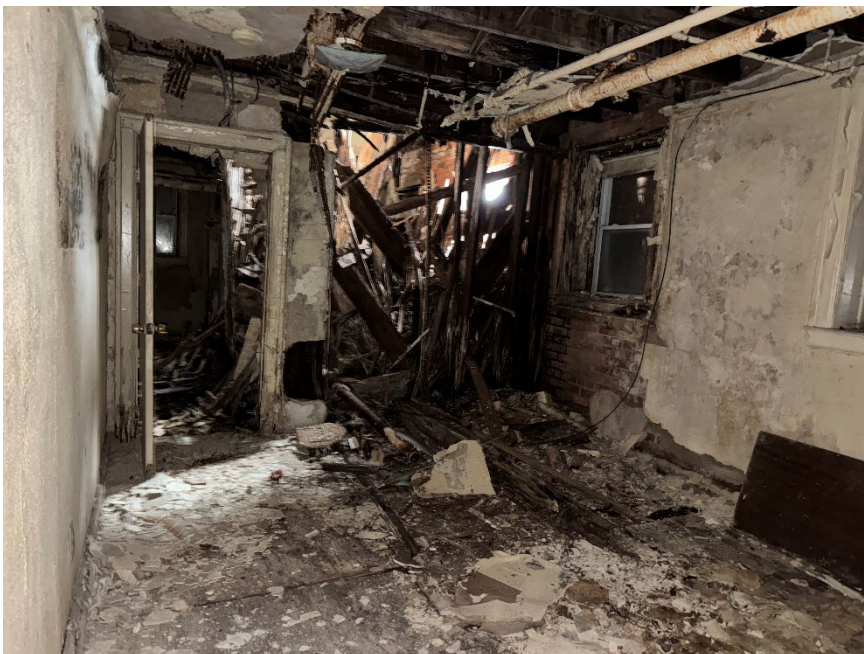
**Photograph #36**

View of collapse in north  
side of subject property  
(from basement)
